Test report

Number T211-0015/25

Product: LED luminaire for road and street lighting

Type reference: DKS850

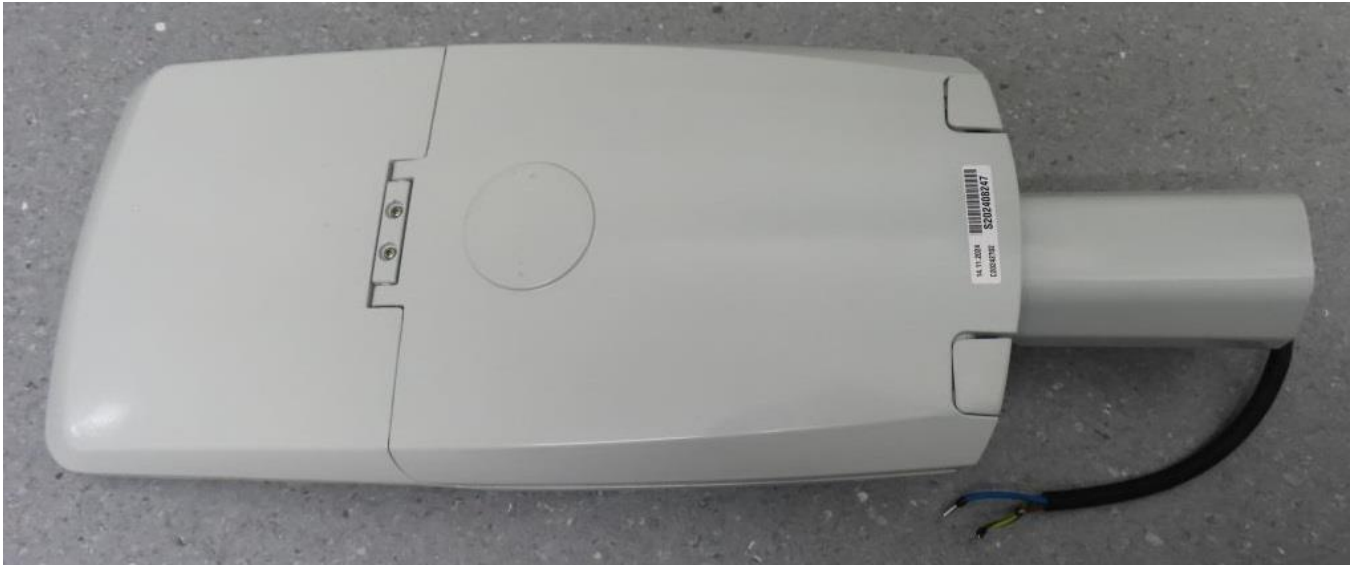
Figure 1

Tested specimen: LED luminaire for road and street lighting DKS850.

Test specimen photo identification:

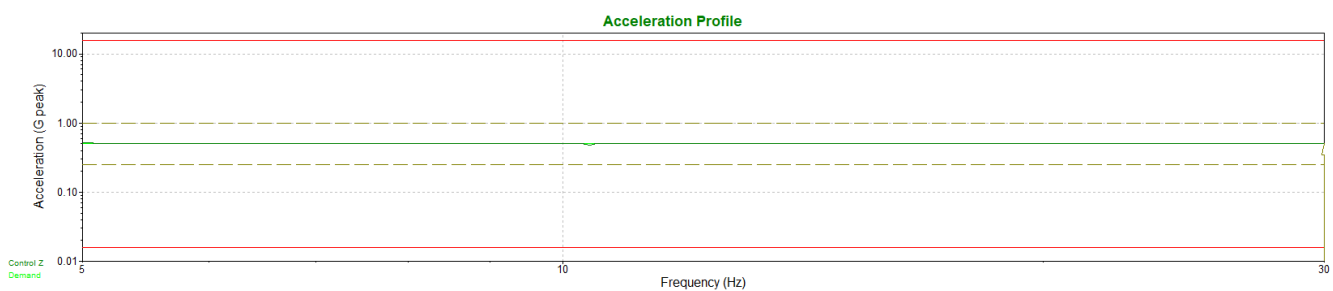
Figure 4

- Non-operating mode.
- $T_{room} = +23\text{ }^{\circ}\text{C}$.
- Frequency range: $5 \div 30\text{ Hz}$.
- Acceleration $0,5\text{ g}$.
- Sweep rate: 1 oct/min .
- Orientation: X, Y, Z direction.

The sweep sine vibration profile is presented in Figure 4.

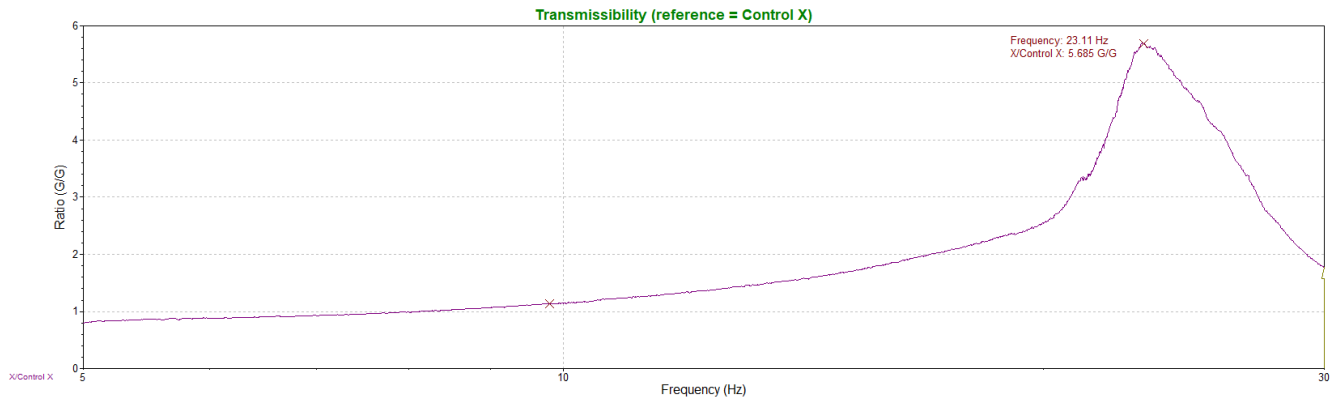
Figure 5

There was resonant frequency detected at 30 Hz, gain 6 (Figure 5),

x axis: frequency [Hz]; y axis: gain = $\frac{A_{res}}{A_{ref}}$

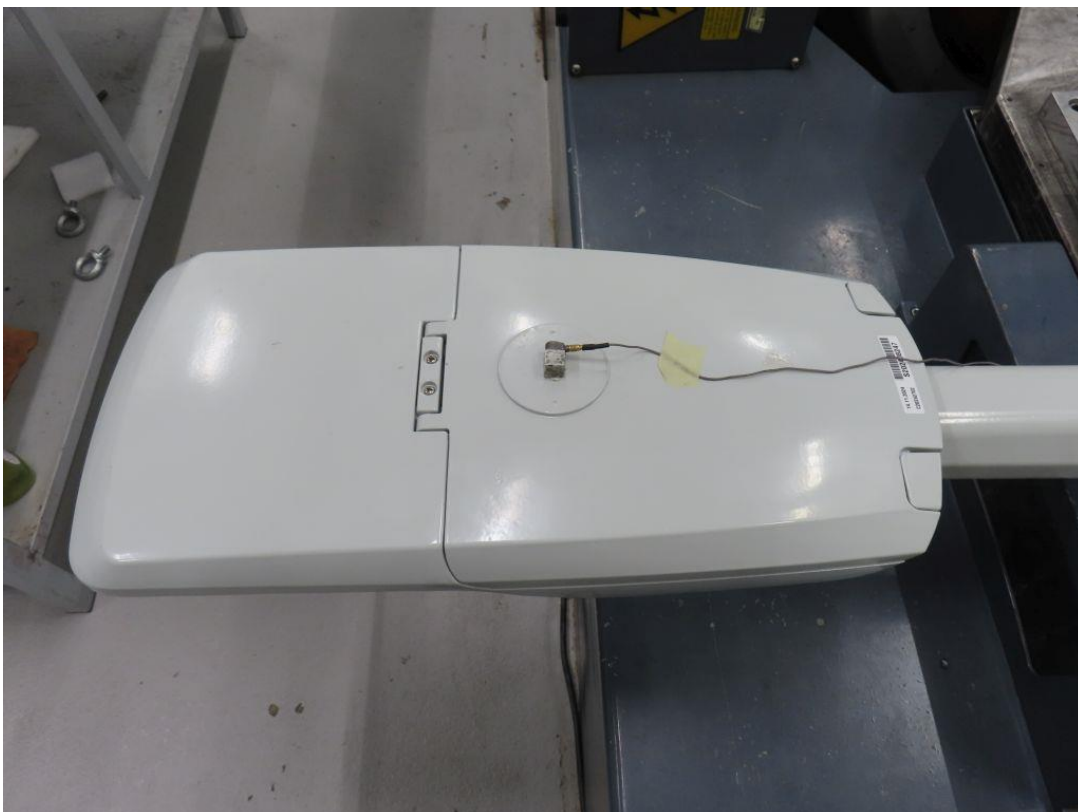
Figure 6

The resonance point detecting test was measured in gravity centre of the luminaire. The resonance is detected if gain of the acceleration is larger than 2.

The location of the resonance point detection sensor is presented in Figure 6.

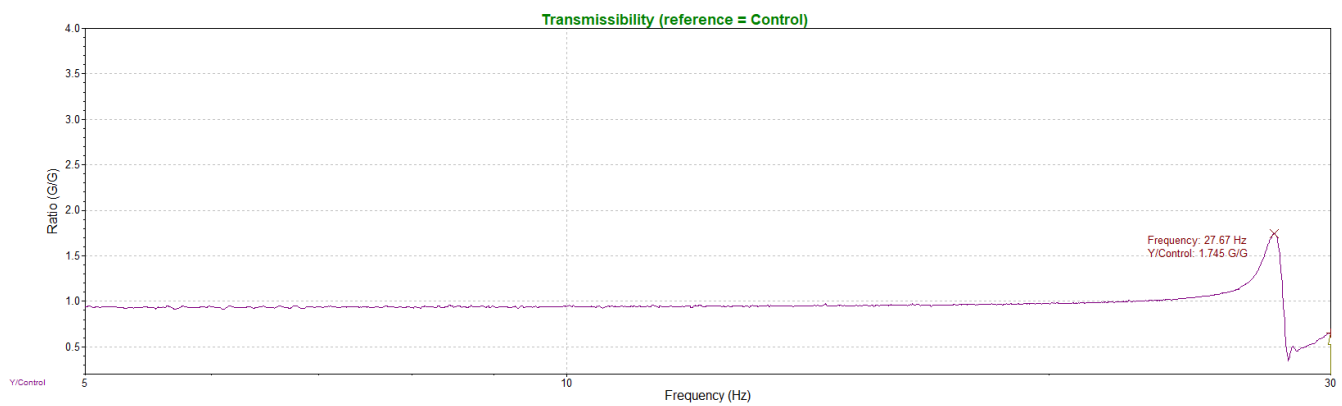
Figure 7

There was resonant frequency detected at 27,67 Hz, gain 1,75 (Figure 7),

x axis: frequency [Hz]; y axis: gain = $\frac{A_{res}}{A_{ref}}$

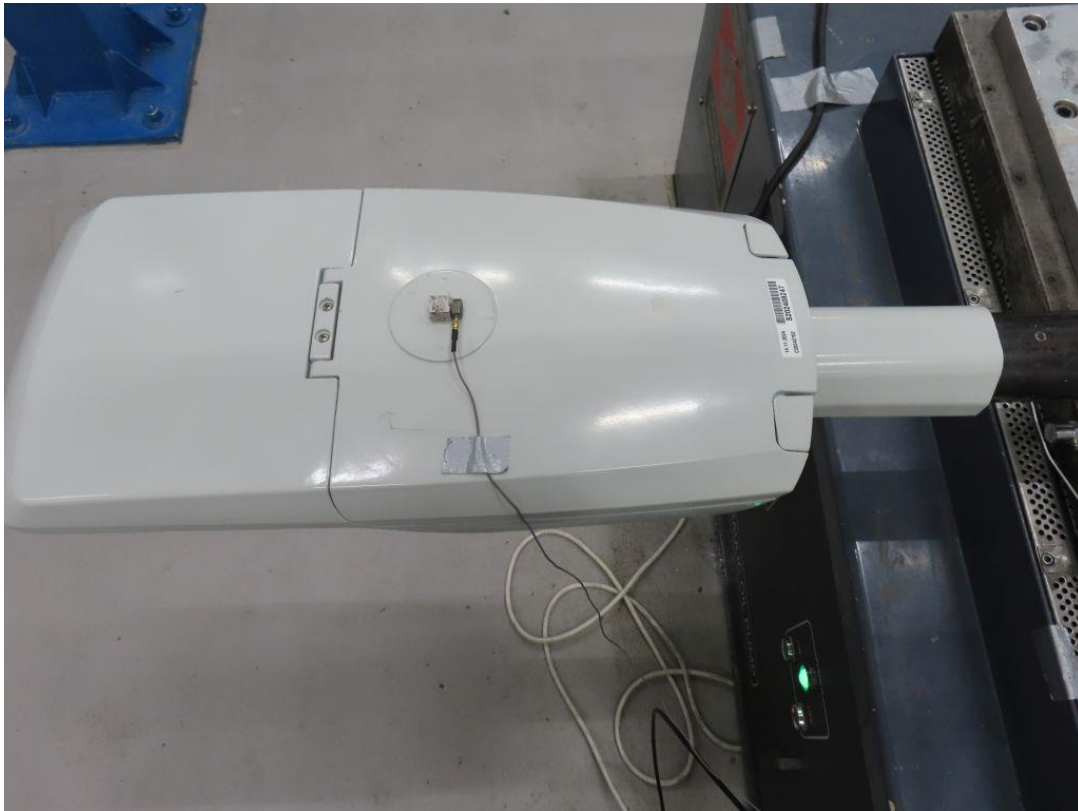
Figure 8

The location of the resonance point detection sensor is presented in Figure 8.

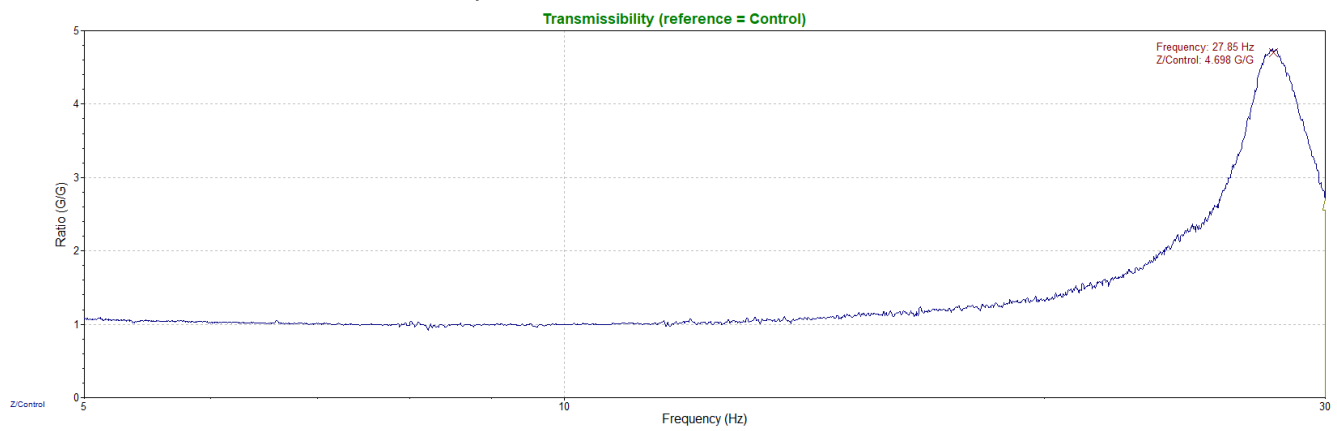
Figure 9

There was resonant frequency detected at 27,85 Hz, gain 4,7 (Figure 9),

x axis: frequency [Hz]; y axis: gain = $\frac{A_{res}}{A_{ref}}$

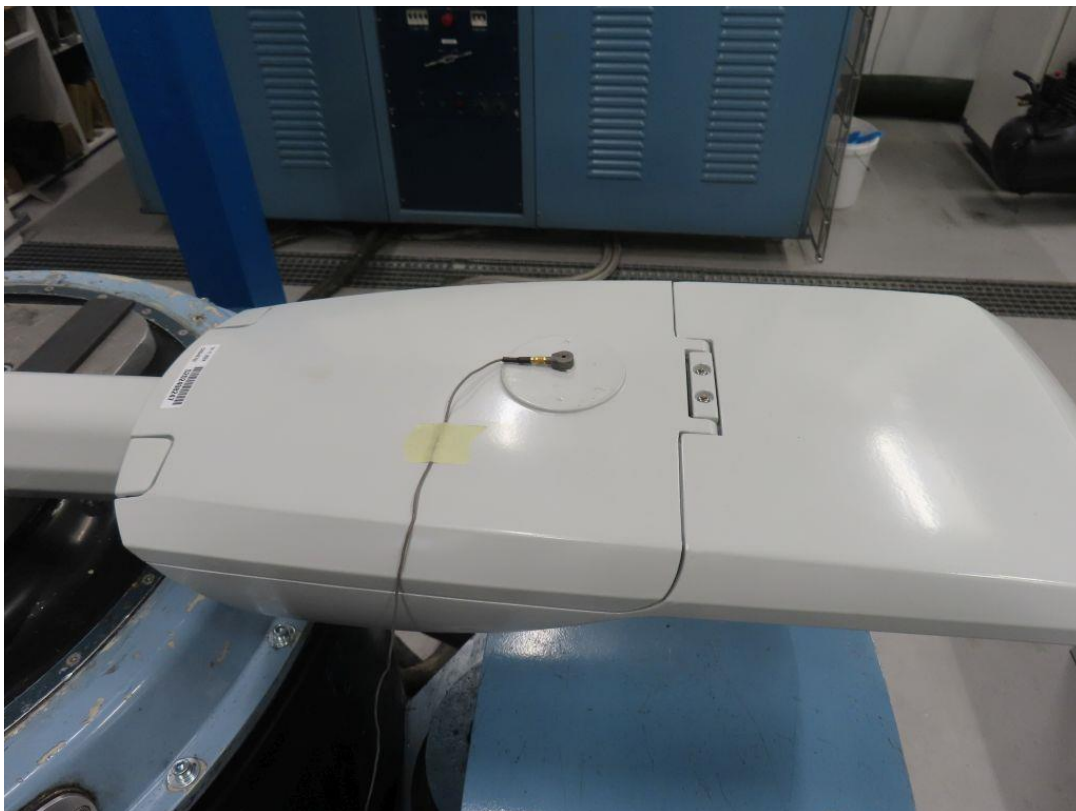
Figure 10

The location of the resonance point detection sensor is presented in Figure 10.

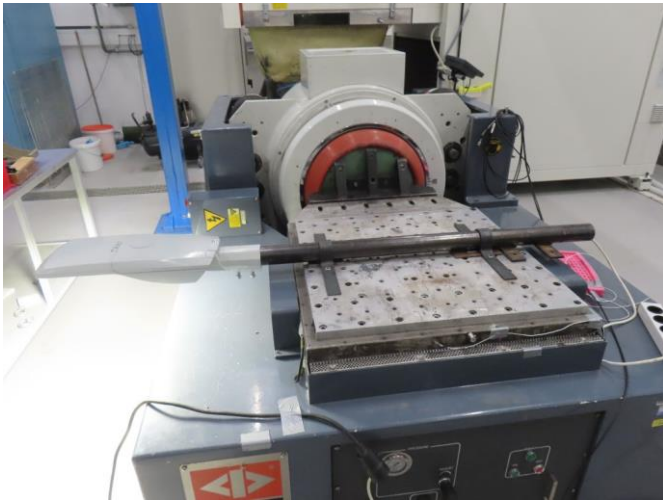
Figure 11: X axis

The sample was exposed to vibration test at resonant frequency for each axis and acceleration of 3 g at the centre of gravity of the luminaire. The fixation of the EUT on the electro-dynamic shaker for X, Y and Z axis is presented in Figures 11 to 13.

- Operating mode, $T_{\text{room}} = +23\text{ }^{\circ}\text{C}$.
- Frequency: 30 Hz.
- Acceleration 0,5 g (Corresponds 3 g at the centre of gravity).
- Duration: 58 minutes (100000 cycles).

During and after the test the luminaire was operating without disturbance. There were no cracks visible.

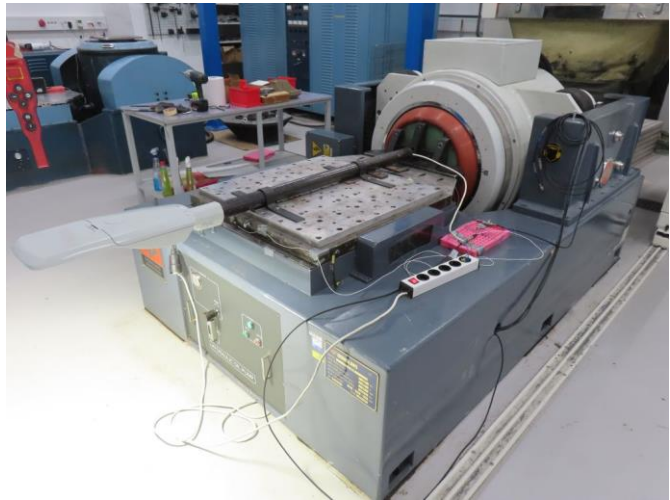
Figure 12: Y axis

- Operating mode, $T_{\text{room}} = +23\text{ }^{\circ}\text{C}$.
- Frequency: 27,67 Hz.
- Acceleration 1,75 g (Corresponds 3 g at the centre of gravity).
- Duration: 1 hour (100000 cycles).

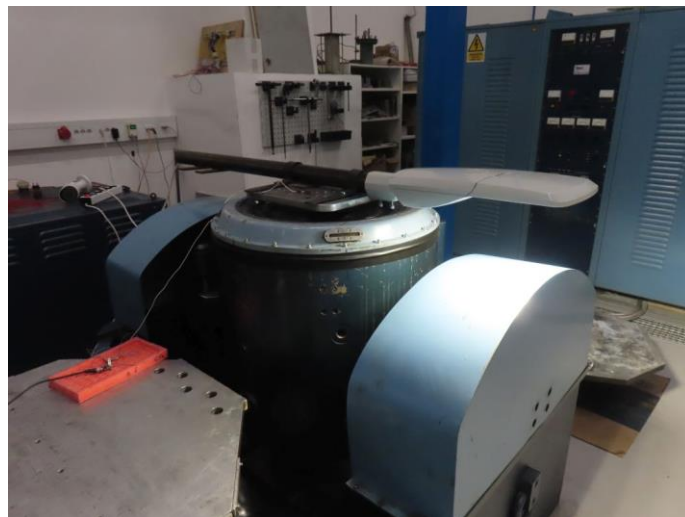
Figure 13: Z axis

- Operating mode, $T_{\text{room}} = +23\text{ }^{\circ}\text{C}$.
- Frequency: 27,85 Hz.
- Acceleration 0,64 g (Corresponds 3 g at the centre of gravity).
- Duration: 1 hour (100000 cycles).

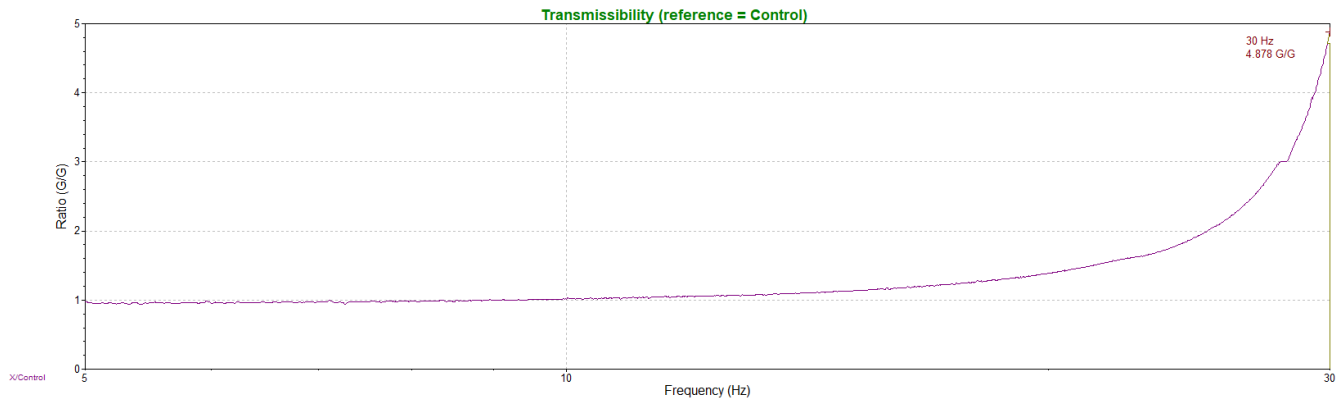
Figure 14

There was resonant frequency detected at 30 Hz, gain 4,88 (Figure 14),

x axis: frequency [Hz]; y axis: gain = $\frac{A_{res}}{A_{ref}}$

Conclusion: There was no significant change of resonant peak between first and final resonant point detection test. There were no cracks visible.

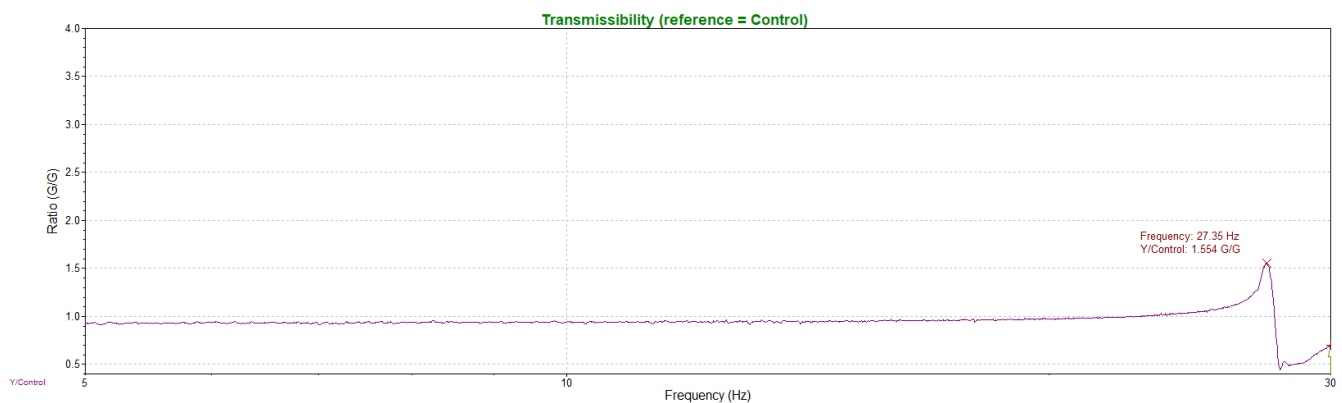
Figure 15

There was resonant frequency detected at 27,35 Hz, gain 1,56 (Figure 15),

x axis: frequency [Hz]; y axis: gain = $\frac{A_{res}}{A_{ref}}$

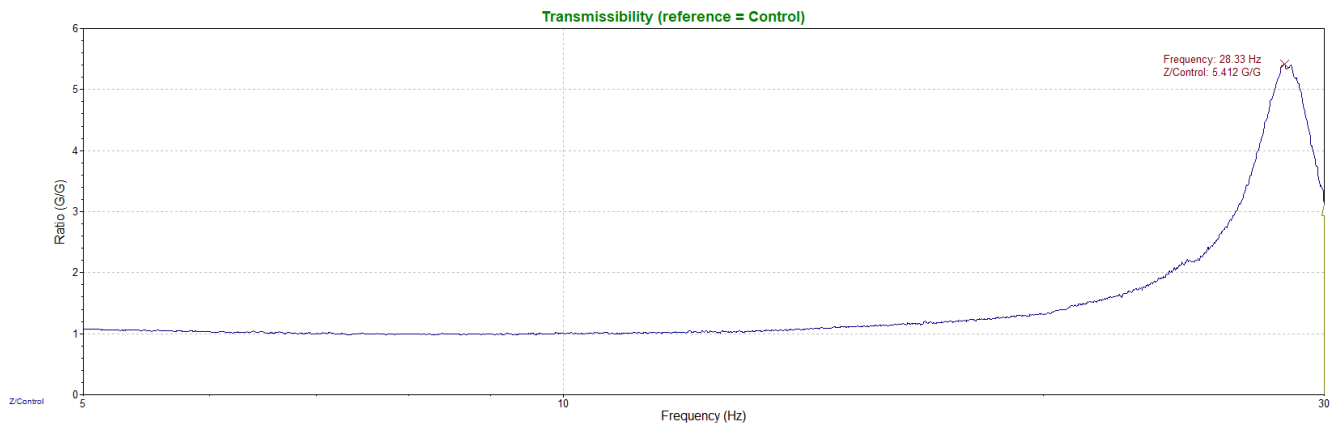
Figure 16

There was resonant frequency detected at 28,33 Hz, gain 5,4 (Figure 16),

x axis: frequency [Hz]; y axis: gain = $\frac{A_{res}}{A_{ref}}$
